CONNECT'S POWER STATION TEAM AVERTS POTENTIAL DISASTER

28 April 2022

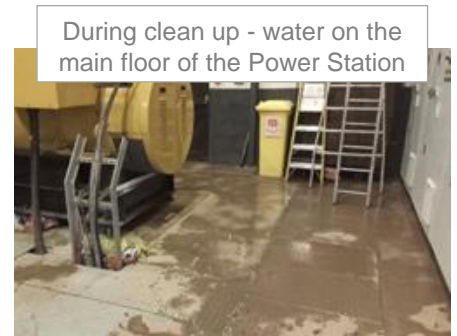
During clean up - water on the main floor of the Power Station

On this occasion, water entered the generator hall and into the cable ducts, causing automatic fail-safes to shut down No. 5 and No. 2 generators (two of the 1MW generators). No. 1 generator (a third 1 MW generator) remained online at that point but was also at risk as water reached further into the generator room.

The team worked into the night to put sand and crushed stone in place to divert the water and to clean up the areas that had flooded. The Electricity Generation Manager led work to assess the generators. Luckily, the water had not triggered a fail-safe shut down on No.1 generator so this could stay online. Work then commenced to clean and make safe the areas that had been impacted.

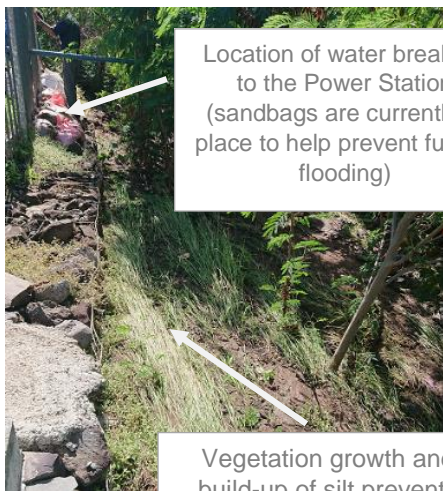
Due to silt build up and overgrown vegetation in the watercourse running throughout Rupert's valley, the huge volume of rainwater caused the watercourse to overrun. Connect staff described gushing water and debris which overtopped Rupert's Run and then entered the Generator Room at the Power Station.

Location of water breakout to the Power Station (sandbags are currently in place to help prevent further flooding)

Vegetation growth and build-up of silt prevents water flowing freely through the water course

A debrief has been held in follow-up to this event. The root cause appears to be the significant rainfall over the Easter weekend which could not escape out to sea as the watercourse was blocked. An SHG contractor has commenced clearing the vegetation from the watercourse.
