## RELINING OF RESERVOIRS - SCOTTS MILL

At Connect St Helena we are in the process of upgrading our water systems across Island. A major part of this involves relining of the existing reservoirs. The reservoir at Scott's Mill has already been relined and another two will be relined this financial year. This week we thought we would 'dive in' and tell you more about how we go about relining a reservoir.

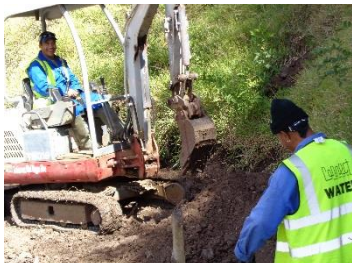
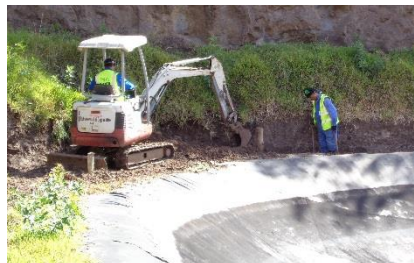
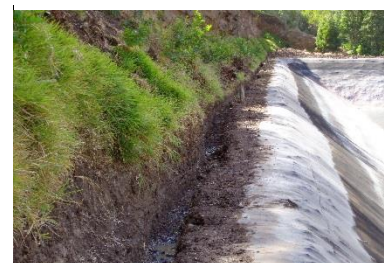
The Scott's Mill project was particularly difficult because time was limited and the project had to be finished before the rainy season began. Before the contractors arrived all the prep work had to be completed. This included clearing vegetation and digging the trenches used to anchor the lining.

*Connect staff doing trenching works around Scott's Mill*
