CONNECT ST HELENA LTD

DEVELOPMENT OF A WATER QUALITY MONITORING PROGRAMME: PHASE 1 REPORT

April 2018

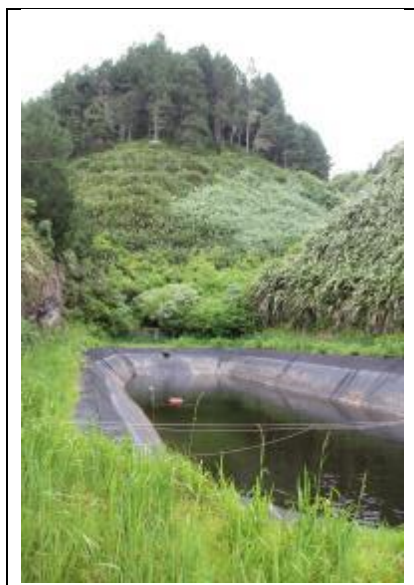
**Plate 1: Grape
Vine Gut
catchment**

The Grape Vine Gut reservoir is located just below the confluence of two small valleys which drain the northern slopes of Diana's Peak (Figure 1). There is no agricultural development in the catchment above the reservoir and the vegetation is primarily flax, with some exotic tree plantations (Plate 1).

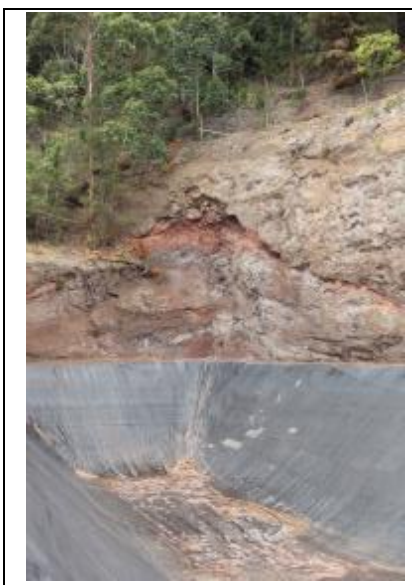
The three Harpers reservoirs are located in a valley immediately to the east of the Red Hill WTW. At the time of sampling, Harpers 1 reservoir was empty to allow repairs to be carried out following a rockfall (Plate 2). The new Harpers 3 reservoir receives water from Oakbank.

**Plate 2:
Harpers 1
reservoir**

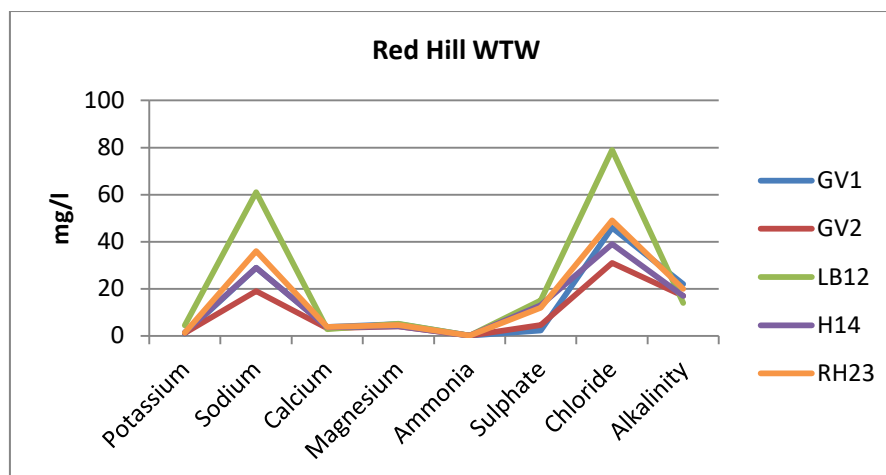
The Grape Vine Gut and Harpers water samples are chemically similar, while the Lady's Bath sample is noticeably higher in sodium chloride (Figure 2 and Table 2). The treated water sample (HG23) is clearly influenced in terms of its salinity by the Lady's Bath water and probably other sources not sampled during this monitoring episode.

Figure 2: Red Hill WTW water quality: major anions and cations

The main issue of concern is the high lead concentration found in the Lady's Bath water. At 20.8 µg/l, this concentration is more than double the EU and SA limit of 10 µg/l (Table 2), however there is sufficient dilution from other sources to ensure that the lead concentration in the treated water supply from the Red Hill WTW (RH23) ***is below the laboratory's detection limits and is therefore safe to drink.***

Lead is rarely present in tap water as a result of its dissolution from natural sources. It is primarily found in drinking-water as a consequence of lead service connections and lead plumbing with a contribution from old high-lead joint solder, leaded brass fixtures and copper alloy fittings, which also contain lead to improve milling characteristics. The amount of lead dissolved from the plumbing system also depends on pH and alkalinity, with soft, acidic water being the most plumbosolvent (WHO, 2017). It was thus postulated that this high concentration could be caused by old lead piping at the spring. This has been investigated and no evidence of lead piping could be found. However, as part of long-term upgrading works envisaged for the site, the old corrugated iron roof and walls surrounding the spring have been removed and the area is now enclosed with steel hand railings.

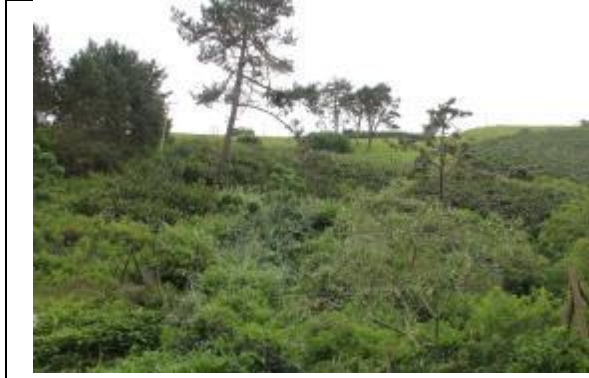
Plate 3: Vegetation around the Willowbank borehole

The catchment area above the Hutt's Gate WTW is characterised by flax, while the area around the WTW is mainly pasture land, with some exotic forestry plantations and dense forest in the valley (Plate 3). Further east, the landscape becomes drier and the vegetation in the mid-valley sections of

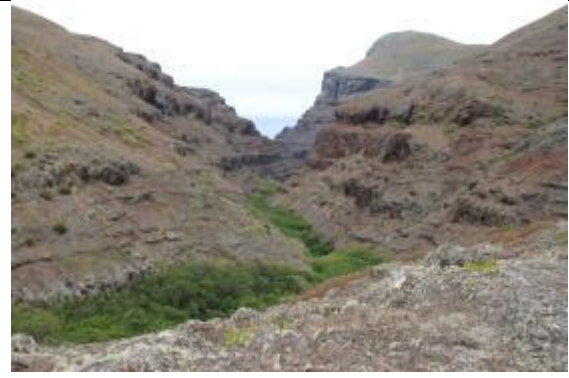
Plate 4: Typical vegetation cover in Shark's Valley. Note dense infestation of wild mango in the watercourse

Shark's, Fisher's and Dry Gut valleys is typified by bare ground, low scrub and some invasive woodland, especially along the water courses (Plate 4). Some wetlands are present along the broad floor of Fisher's Valley close to the location of the boreholes (see photo in Sample Log). Some arable agriculture is practised in Fisher's Valley (Longwood, Tobacco Plain) and Shark's Valley (below Levelwood and Silver Hill).

The Shark's Valley water abstraction point is located near Levelwood (Figure 1). Shark's Valley has quite a large catchment, draining the eastern slopes of Diana's peak. The main tributaries include Warren's Gut, Pleasant Valley and Taglate Valley. Catchment land use and vegetative cover comprises flax on the upper slopes of the mountain, with extensive agricultural land (arable and pasture), plantations and alien vegetation on the mid-slopes. Further downstream the valley slopes are largely bare or support sparse scrubby plants, while the river valley is choked with wild mango (Plate 4). The settlements of Woody Ridge, Silver Hill and Levelwood are situated in this catchment.

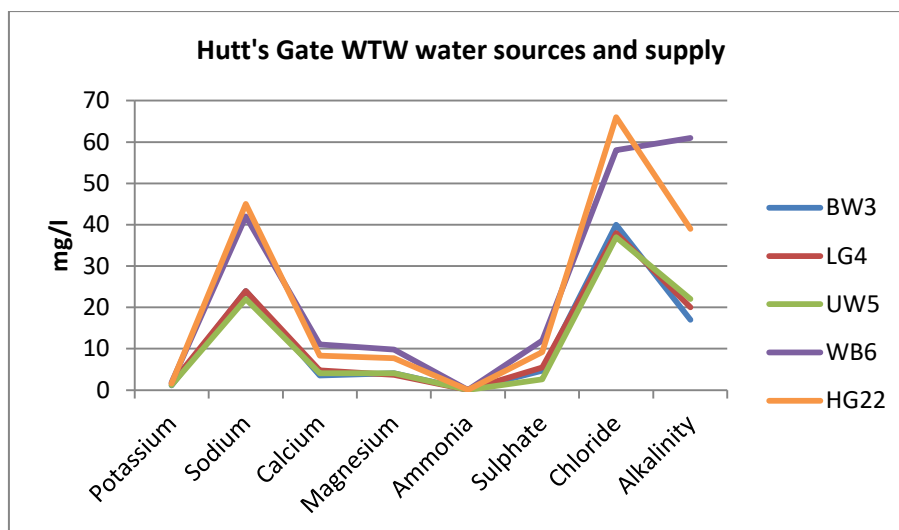
The water from Legg's Gut (LG4), Upper and Lower (Bottom) Wells (UW5, BW3) is chemically the same with respect to cations, anions and dissolved metals, while the Willowbank borehole water (WB6) has significantly higher levels of sodium chloride salts and lower iron, as might be expected in a groundwater sample (Figure 3 and Table 3). This is confirmed by the results of the sample taken in 2015. Since water from the Willowbank borehole is pumped on a daily basis to cover the deficit of water abstracted from the springs feeding the Hutt's Gate WTW, it is unsurprising that the treated water from the Hutt's gate WTW is very similar to the Willowbank water quality (Figure 3).

Figure 3: Hutt's Gate WTW water quality: major anions and cations

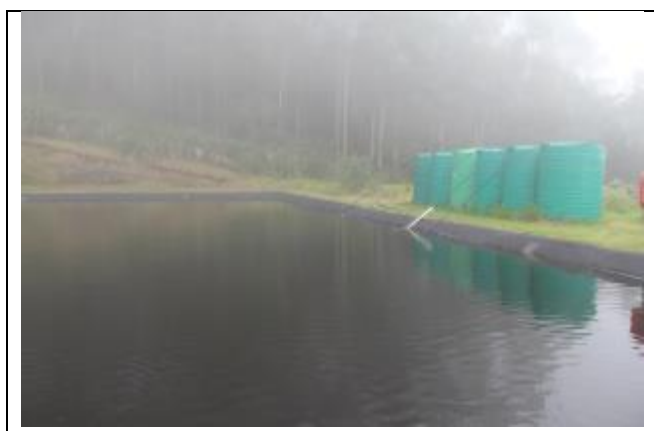
The Levelwood WTW is currently only supplied with water being gravity fed from Deep Valley to a reservoir at the WTW (Figure 1 and Plate 5), but it is possible that water from the Jimmy Lot's spring could be pumped to the Levelwood WTW in future. The Levelwood WTW is situated in the south-east of the Island on a ridge between Deep Valley and Pleasant Valley (Figure 1). Deep Valley has its origins high up on the south-east flank of Diana's Peak and the vegetation in the upper catchment is dominated by flax. The middle section of the valley around the WTW is largely covered with exotic plantations.

Plate 5: Levelwood reservoir, with the WTW located below the green tanks.

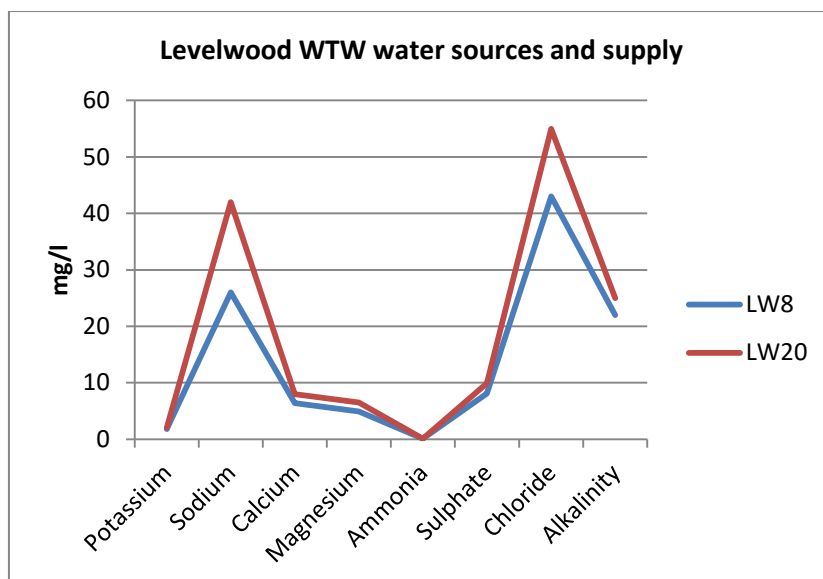
Given that there is only once source of water entering the WTW (LW8), it would be expected that the treated water (LW20) would have a similar chemical signature, but sodium, chloride and iron are all noticeably higher in the treated water sample (Figure 4 and Table 4).

Figure 4: Levelwood WTW water quality: major anions and cations

The **iron** content in the treated water is over the EPO/WHO/EU recommended guideline limit of 0.2 mg/l, but within the SA standard of 0.3 mg/l (Table 4).

Iron concentrations in the range 0.1 to 0.3 mg/l, as found in the Levelwood water, will give the water a very slight metallic taste and possibly cause iron staining and deposition on plumbing. However there are no adverse health effects associated with this level of iron.

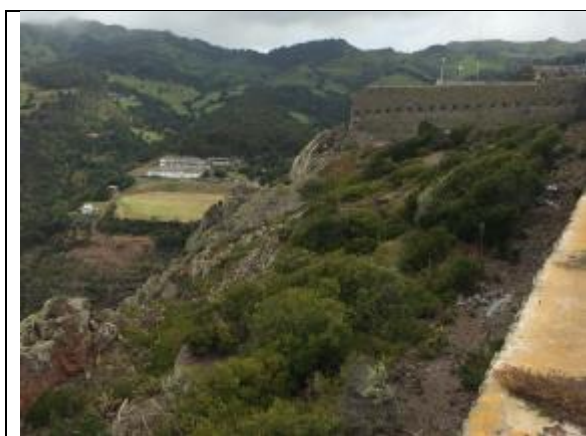
Plate 6: Catchment above Jamestown WTW supply springs showing Prince Andrew school and playing fields, pasture land and plantations

The catchment above the springs is severely disturbed with residential areas, roads, the Prince Andrew School and playing fields, Harper's reservoirs and associated water supply infrastructure, intensive agriculture (open and in tunnels), dense forest, rough scrubby vegetation and bare mountain slopes (Plate 6).

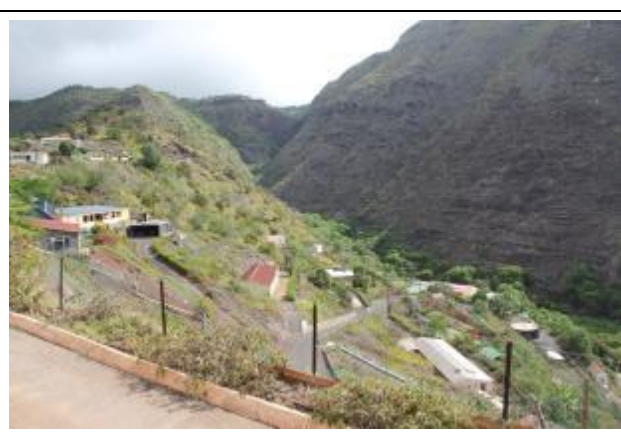
Plate 7: Jamestown WTW (black tank on lower right of photo), showing valley where Black Bridge, Drummond's Point and Tom Peters springs are located

The Jamestown WTW is located on the edge of The Briars residential area and it supplies this suburb, as well as Jamestown and Rupert's Valley (Plate 7).

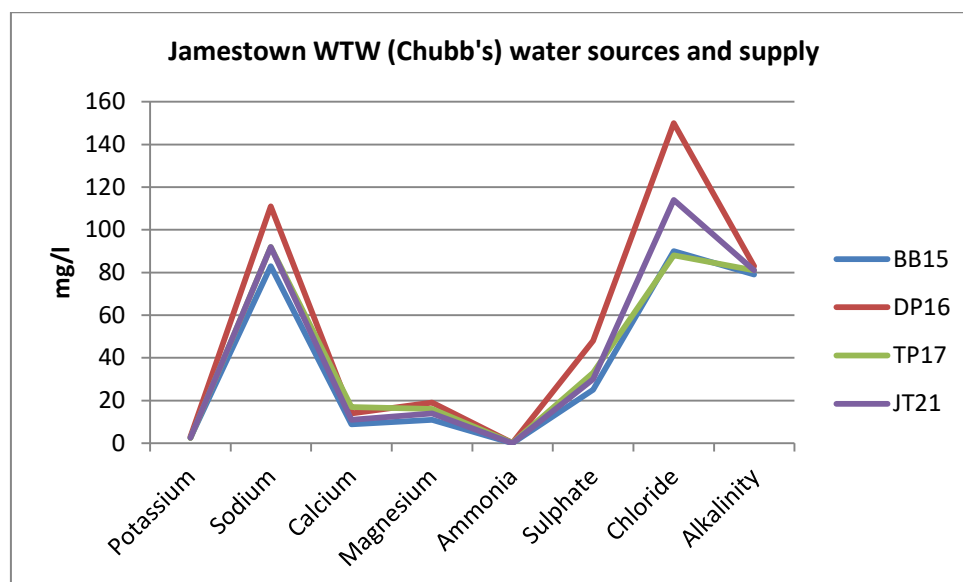
The Drummond Point water clearly has an impact on the overall quality of the treated water (JT21), which shows elevated chloride levels compared to other sampled water sources.

Figure 5: Jamestown WTW water quality: major anions and cations

Chloride levels in the range 100-200 mg/l, as found in DP16 and the treated water (JT21), do not have any adverse health or aesthetic (taste) effects, but values over 50 mg/l (all samples), together with a high conductivity are indicative of a serious potential for corrosion (see s 4.4.4 below).

The LSI for the Jamestown WTW treated water is -3.8, indicative of a serious corrosion risk, primarily due to the contribution of water with elevated sodium chloride from the Drummond Point source (Table 5). Water from the Jamestown WTW supplies Rupert's Valley where the new Bulk Fuel Facilities (BFI) for the Island and airport are being constructed. One of the main concerns of the design engineers and fuel management contractor is the level of chloride in the treated water supply they use in the firefighting systems for the fuel facilities. A chloride concentration of less than 50 mg/l would be optimal, but less than 100 mg/l could be tolerated. It is recommended that consideration needs to be given to the water supply operating system to see if the contribution of water from Drummond Point could be reduced, or greater dilution could be achieved for the Rupert's valley supply.

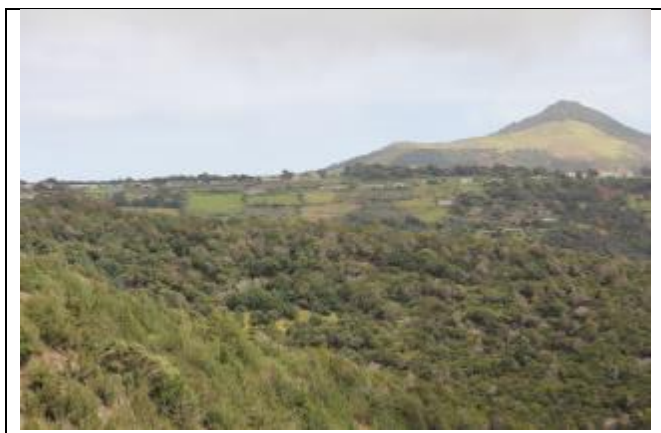
Plate 8: View of the Longwood agricultural area from the Jimmy Lots tank near Woody Ridge

Water is fed by gravity from the Jimmy Lots spring in Warren's Gut to a tank next to the road near Woody Ridge (Figure 1). Warren's Gut flows off one of the east-facing slopes of Diana's Peak and the catchment is mostly under flax. The water is used for irrigation in Longwood and on Tobacco Plain (Plate 8), however, there are plans to pump water from the Jimmy Lots spring to either the Hutt's Gate or Levelwood WTWs in future.

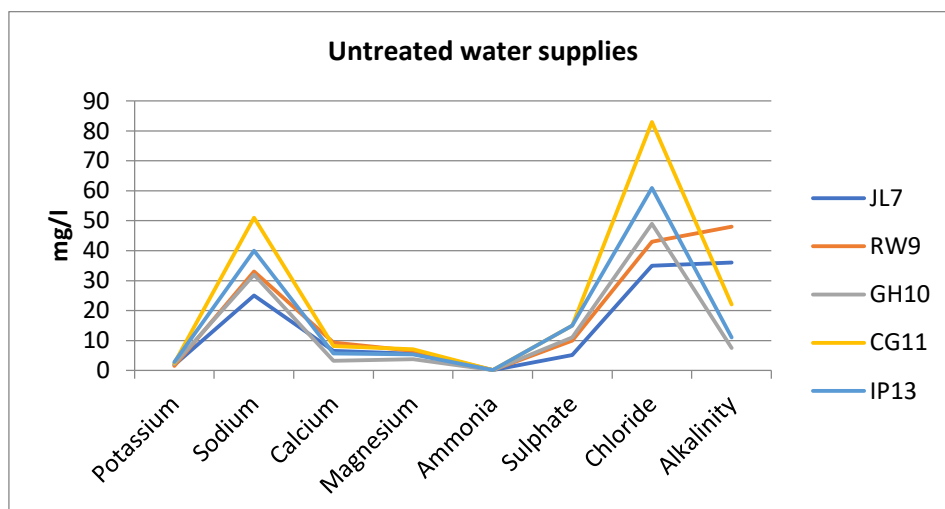
The water is good quality, with no sign of any anthropogenic pollution, except for a high iron content (0.8 mg/l), which exceeds the guideline limits for drinking water on the grounds that it will impart a

distinctly metallic taste to the water and cause problems with plumbing (Table 6 and Figure 6). However, there would be no adverse health effects at this concentration.

Figure 6: Untreated water sources: major anions and cations

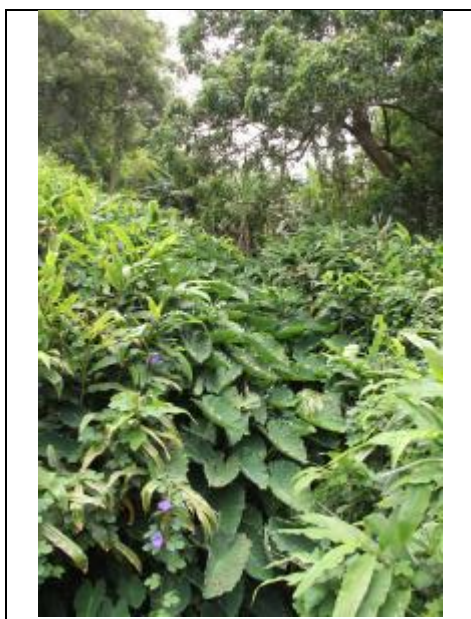
The Rockwater spring is found in one of the small lower tributaries of Mount Pleasant (Figure 1). There was very little flow at the time of sampling and the water in the small weir contained green algae (see photo in Sample Log). The catchment valley is densely vegetated (Plate 9). Raw water from this source supplies the western parts of Sandy Bay, where it is used for irrigation and domestic use.

**Plate 9: The overgrown
Rockwater catchment**

In spite of the presence of some algae, the quality of water from this source is good and it is compliant with the drinking water guidelines, with no adverse aesthetic or health effects (Figure 6 and Table 6). No signs of pollution are evident and the water is suitable for all crops and livestock watering. However, there is a serious risk of corrosion, with an LSI of -3.8.

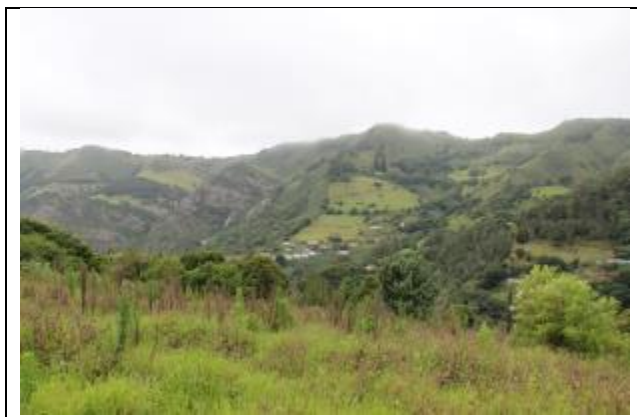
Plate 10: View of the Green Hill area

Water is piped via gravity from Wash's Gut to a holding tank at Green Hill, where sample GH10 was collected. Wash's Gut forms one of the upper tributaries of Powell's Valley draining the southern slopes of Diana's Peak (Figure 1). The catchment area is mostly covered with flax, but there is some arable and pasture land. Water from this source supplies the Green Hill area (Plate 10).

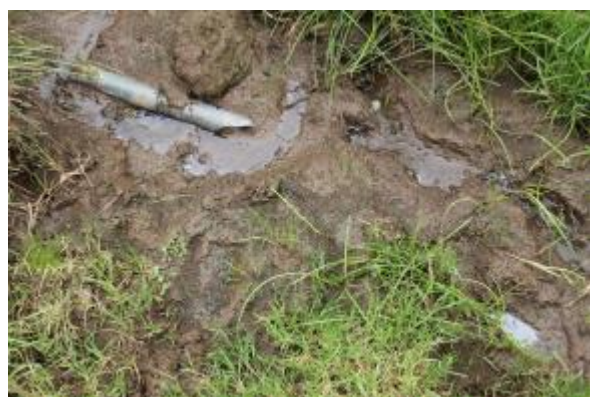
Two boreholes have been developed in Frenches Gut at the upper end of Lemon Valley on the west side of the Island (Figure 1). The boreholes are located 100 m apart in pastureland, with one being a vertical hole to 30 m; the other is an artesian source accessed via a horizontal hole (Plates 11 and 12). Raw water from this source is supplied to the communities of Blue Hill, Head O'Wain, Burnt Rock, Horse Pasture and Thompson's Wood, as well as to the public tap at the Cason's Gate parking area (where the sample was collected).

Plate 11: The outlet of the horizontal borehole in Frenches Gut. Note oily film on the water surface

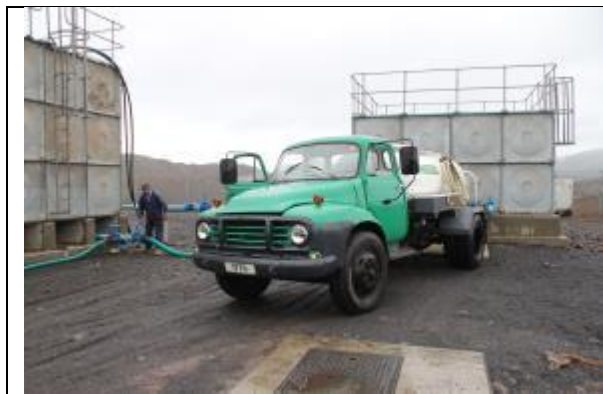
Plate 13: Connect collecting Borehole 5 water at the Fire Water tank in February 2017 as part of the drought relief strategy

Borehole 5 water complies with all the drinking water standards when it is being pumped on a regular basis as mentioned above. If it is allowed to stay in contact with the underlying geology for a few days, it becomes noticeably saltier and unfit to drink.

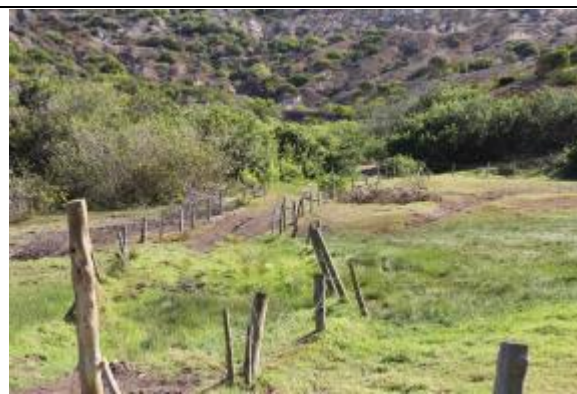
Plate 14: Typical vegetation in Fisher's Valley

above the Hutt's Gate WTW is largely composed of flax and some plantations. As one moves away from the higher slopes, agriculture (pasture and arable) becomes quite dominant in the landscape, which in turn merges into Crown wastes and sparsely vegetated slopes as one moves downstream (Plate 14). The two boreholes in Fisher's valley lie upstream of Cook's Bridge, in pasture land upstream of the wetland area (Figure 1).

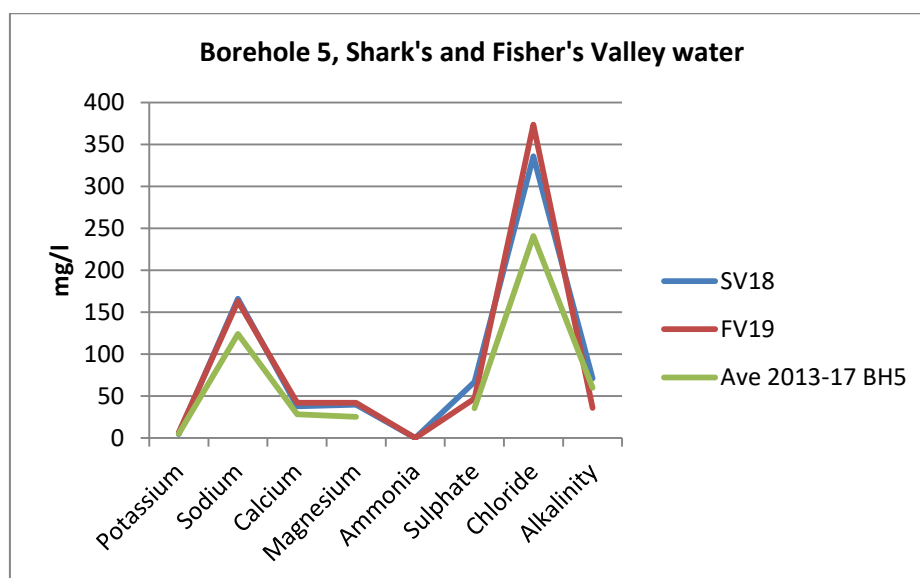
Figure 7: Shark's and Fisher's Valleys water quality: major anions and cations

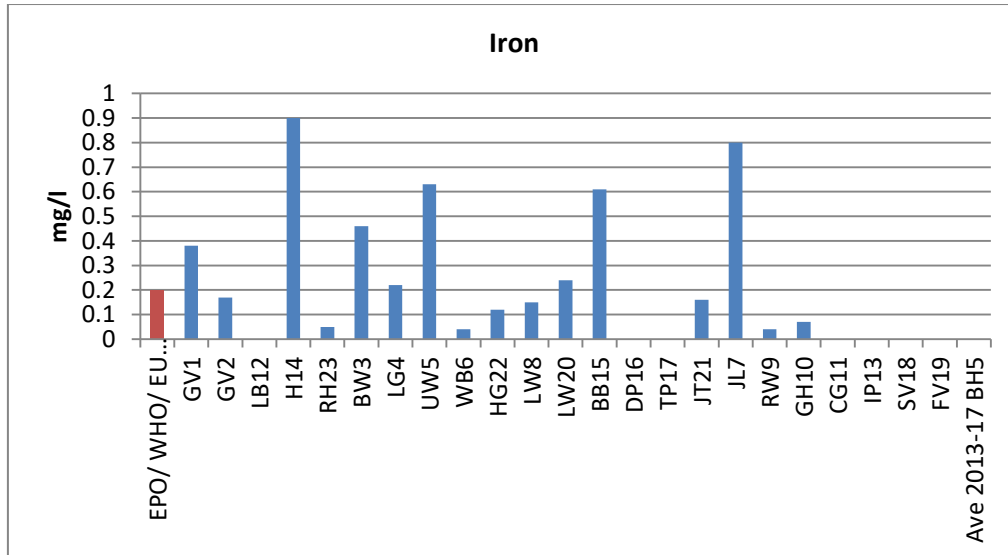
Manganese levels are non-compliant in two samples: Harpers 2 reservoir and Iron Pot. In both cases the source is likely to be natural and there would be no adverse health effects at these levels. The main impact will be on taste (minor) and possible staining of laundry.

Figure 8: Iron concentrations in all water samples compared to the guideline limit for drinking water

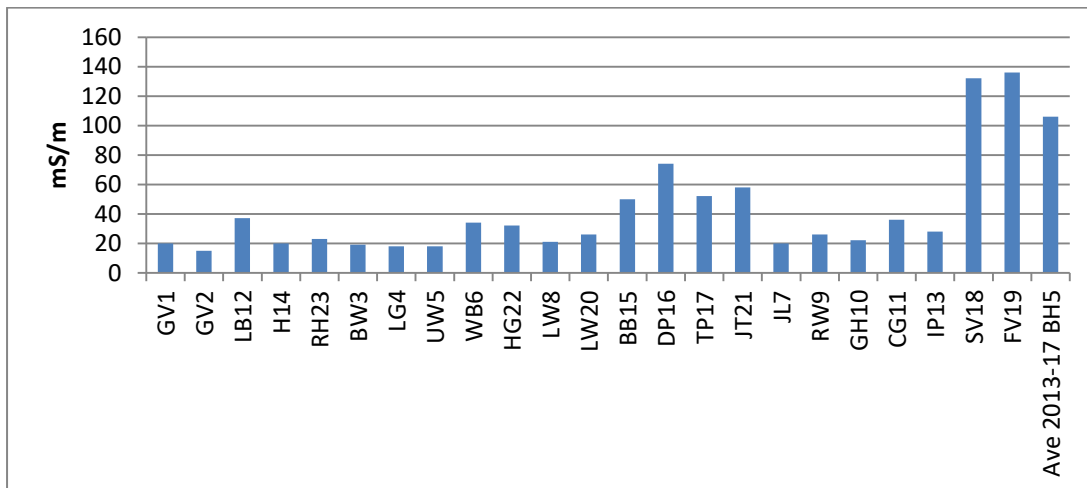
The conductivity of all samples is within the target water quality range of 0-170 mS/m, but the levels are over the aesthetic limit of no adverse effects of 70 mS/m in the Drummond Point (DP16) source and the potential new supplies in Fisher's and Shark's Valleys and Borehole 5 (Figure 9). The salinity is caused by natural sodium chloride salts found in the volcanic rocks and soils of the Island, especially on the dry eastern side. However, the salinity levels of these samples should give no cause for concern for drinking water quality, but may have an impact on irrigated crops. All the WTWs are compliant with regard to sodium, chloride and conductivity levels.

Figure 9: Conductivity of all samples

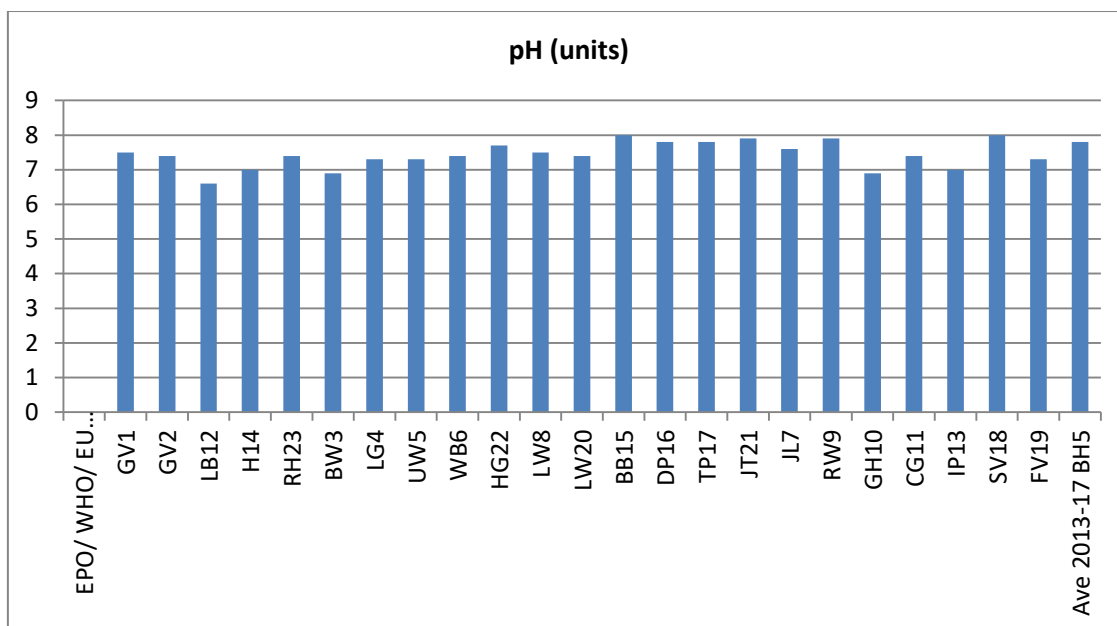
The pH of all samples analysed fell within the specified range for drinking water of 5 – 9.7 as shown in Figure 10. The lowest pH was encountered in Lady's Bath (LB12) at 6.6 and the highest (8.0) was found in Black Bridge (BB15) and Shark's Valley (SV18).

Figure 10: pH of all water analysed.

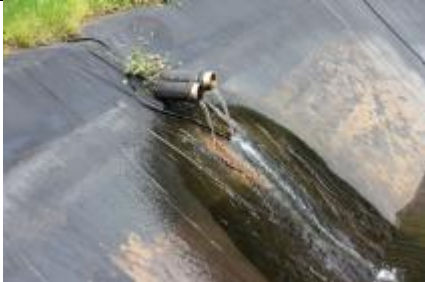
Pipe 1 (GV1) is on the left (looking towards pipes); Note iron (orange) precipitation below Pipe 1, with less below Pipe 2 on right; Colour: clear Sediment: slight Supplies Red Hill WTW
Grape Vine Gut reservoir inflow pipe 2 (right)	GV2	Surface

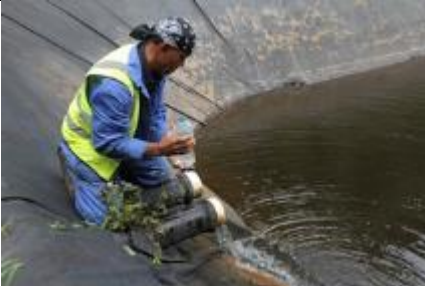
Collecting sample from Pipe 2 (GV2); Colour: clear Sediment: more than GV1 Supplies Red Hill WTW
Hutt's Gate reservoir inflow pipe 1 from Lower (Bottom) Wells	BW3	Surface

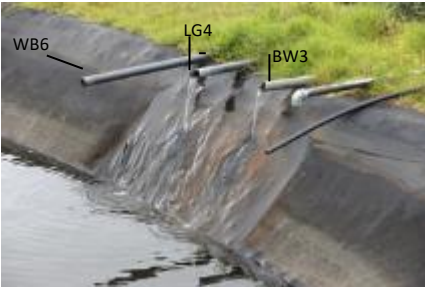
BW3 (third pipe from left); Iron precipitation below pipe; Colour: pale yellow Sediment: slight Supplies Hutt's Gate WTW
Hutts Gate reservoir inflow pipe 2 from Upper and Lower Legg's Gut	LG4	Surface		LG4 (second pipe from left); Slight iron (orange) precipitation; Colour: very pale yellow Sediment: very slight Supplies Hutt's Gate WTW

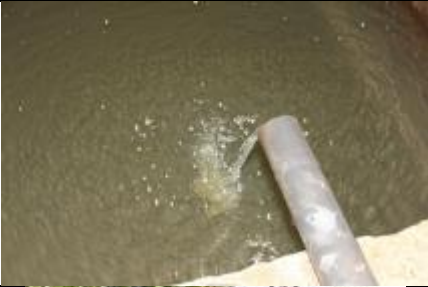
<p>Colour: very pale yellow</p> <p>Sediment: none visible</p> <p>Supplies Hutt's Gate WTW</p>
Willowbank borehole holding tank	WB6	Groundwater

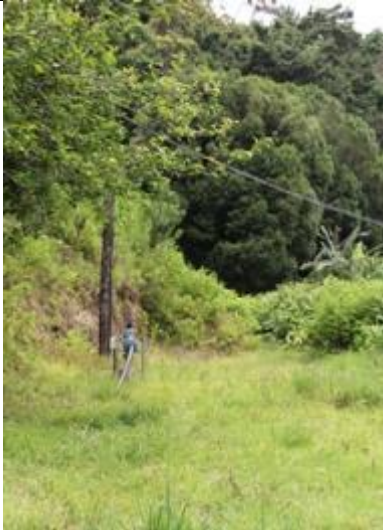
<p>Willowbank borehole pump;</p> <p>Water pumped to Hutt's Gate reservoir;</p> <p>Colour: clear</p> <p>Sediment: none visible</p> <p>Supplies Hutt's Gate WTW</p>

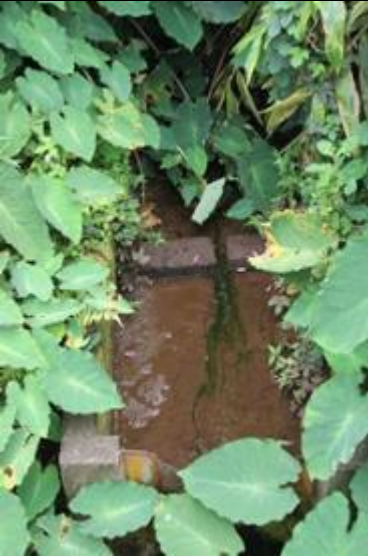
<p>Rockwater weir with algae (green) and iron precipitation (orange);</p> <p>Very low flow, sample taken from tank;</p> <p>Provides raw water to western parts of Sandy Bay where used for irrigation and domestic use;</p> <p>Colour: clear</p> <p>Sediment: moderate</p>
Inflow pipe from Wash's Gut to Green Hill tank	GH10	Spring

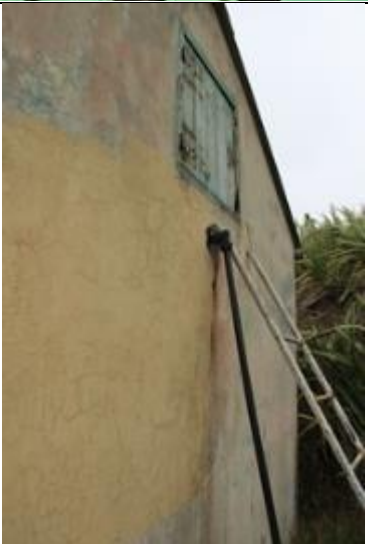
<p>Water from Wash's Gut is fed by gravity to the Green Hill reservoir (GH10);</p> <p>Supplies untreated water to the Green Hill area;</p> <p>Colour: very pale yellow</p> <p>Sediment: slight</p>

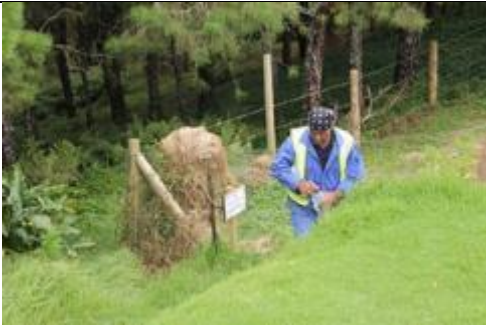
<p>The tap at Cason's Gate parking area is fed from 2 boreholes in Frenches Gut (upper Lemon Valley);</p> <p>Boreholes supply Blue Hill, Head O'Wain, Burnt Rock, Horse Pasture, Thompson's Wood with untreated water;</p> <p>Boreholes 100m apart;</p> <p>One drilled to 30 m; the other is artesian (horizontal hole);</p> <p>Colour: clear</p> <p>Sediment: very slight</p>
Perkin's Gut	Not sampled	Surface	No photo	Supplies untreated water to parts of Sandy Bay
Wrangham's Sping	Not sampled	Surface	No photo	Supplies untreated water to the upper parts of Sandy Bay
Inflow pipe to weir at Lady's Bath	LB12	Spring

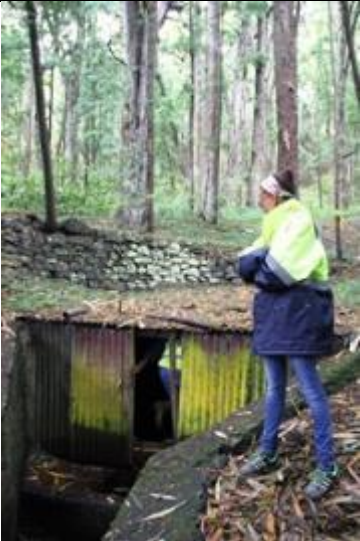
<p>Surface water from Lady's Bath spring is fed by gravity to Red Hill WTW;</p> <p>Sample collected from tank due to low flow;</p> <p>Colour: clear</p> <p>Sediment: none visible</p>
Raw water tank pumped from Iron Pot borehole	IP13	Groundwater	No photo of tank due to rain	<p>Water pumped from Iron Pot borehole in upper Lemon valley near Cason's Gate to tank near Cason's (Gold Mine Tank);</p> <p>Provides raw water to High Point, Blueman's Field and St Pauls</p> <p>Colour: clear</p> <p>Sediment: none visible</p>

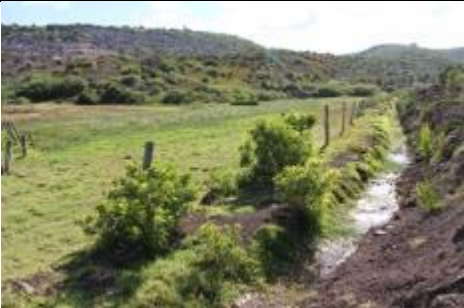
2 boreholes in Fisher's Valley; Pump station and balancing tank receives water from Shark's Valley and Borehole 5 and pumps to Hutt's Gate WTW in times of drought.
Borehole 5	BR results	Groundwater

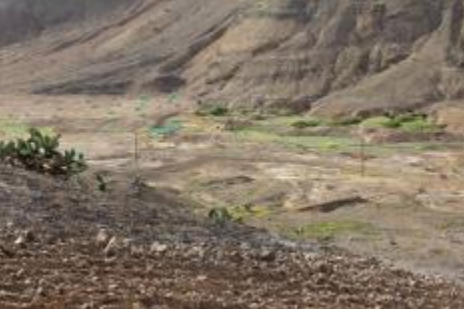
Borehole in Dry Gut; Pumped to Firewater tank for use at airport. In times of drought can be pumped to the Fisher's Valley balancing tank and thence to Hutt's Gate WTW; Colour: clear Sediment: none
Levelwood WTW sampling tap	LW20	Treated potable water		Supplies the communities of: Silver Hill, Levelwood and Sandy Bay
Jamestown WTW (Chubbs) sampling tap	JT21	Treated potable water		Supplies the communities of: Jamestown, The Briars, Rupert's Valley
Hutt's Gate WTW sampling tap	HG22	Treated potable water		Supplies the communities of: Longwood, Bottom Woods, Airport, Deadwood, Alarm Forest, Hutt's Gate
Red Hill WTW sampling tap	RH23	Treated potable water		Supplies the communities of: Half Tree Hollow, Cow Path, Red Hill;
